Vibration control in a tunnel under an office rehabilitation project

Marc Asselineau¹, Stéphane Mercier¹

¹ Peutz & Associés, F-75010 Paris, France, Email: peutz@club-internet.fr

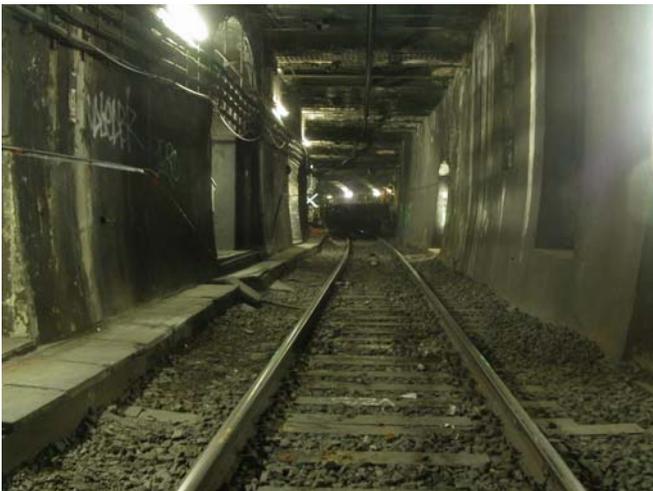
Over the years the line was modernized, with overhead replacing the third rail and more modern rolling stock taking over. However it was not possible to increase the loading gauge or to broaden the curves (Figure 1). With the opening of the rail connection between Orsay and Invalides this former branchline was eventually turned into a major part of the Paris express rail network, with a train running every 2 mn on each track at peak hour.

Figure 1: The tunnel before rehabilitation; note the reduced loading gauge and the structural connections of the track to the tunnel walls.

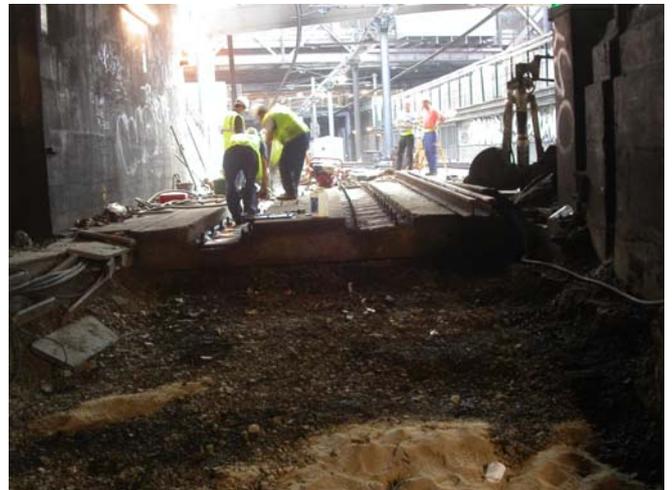
Figure 2: Entrance to the tunnel under the building; note the concrete structure in the background.

Right out of the tunnel by the administrative building the track was rigidly laid on a concrete structure structurally connected to the tunnel (Figure 2). It was found out that vibratory energy was transmitted from this zone too.

Meanwhile the original rail fasteners on the concrete portion out of the tunnel were removed and replaced by resilient fasteners by Pandrol. Care had of course been taken to ensure that the ballast mat from the tunnel was laid along the edge of the concrete structure so as to prevent vibration transmissions at this end.

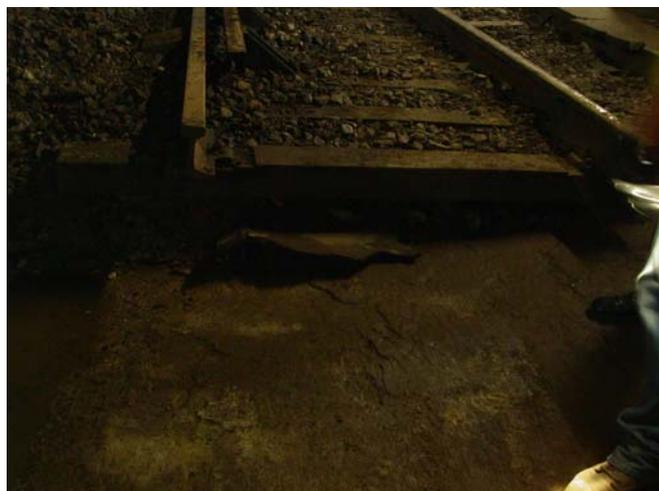
Figure 3: Cross section of the trackwork showing the larger than usual ties thinned on one side.

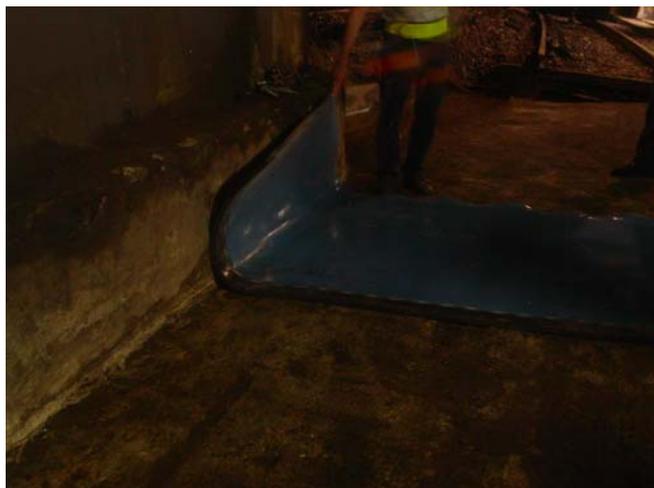
Figure 4: The resilient mat by Sylomer glued to the floor and lower walls of the tunnel.

Basically, the vibration control measures called for a resilient mat under and on each side of the ballast, with careful consideration being given to the overall thickness as it could eventually foul the loading gauge. In addition, the ground floor of the building over the tunnel was rebuilt using a thick concrete slab.

Advantage was taken of a summer break in the operation of the line due to heavy track renewal further down the line. Over two shifts of two weeks, one for each track, the old track and ballast were removed, and then the ground was carefully scrapped so as to erode any protrusion. Resilient mats by Angst+Pfister (Sylomer 25B) were then glued in position (Figure 4), with particular care to ensure that the junctions between mats were tight enough to prevent the intrusion of ballast material. A first layer of ballast was then spread over the mats in order help stabilize it, and the top of the mat was then glued and protected using a metal inverted L profile. The track was then laid ; this time no rigid connections to the walls of the tunnel were allowed but in order to help stabilize the trackwork a steel paddle was added at the tip of some of the sleepers. Prior to adding more ballast, the clearance between the bottom of the paddle and the mat was carefully checked. After completion of the ballast a careful examination was performed in order to spot any zone where ballast might have been spread over the top of
