# Noise induced vibration of a thin projection screen

N.Bert Roozen<sup>1,2</sup>, Luuk Yperlaan<sup>3</sup>

## Introduction

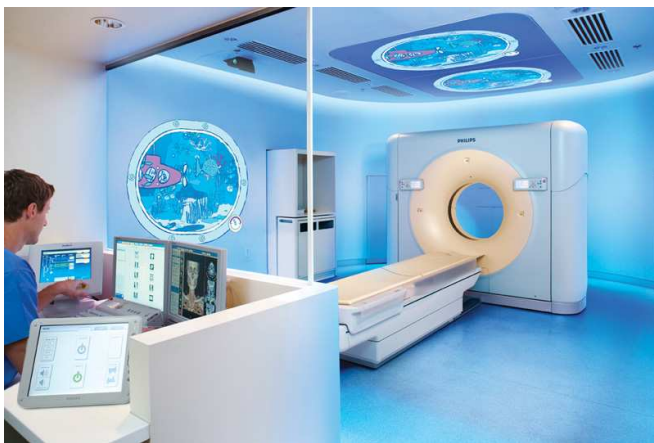
**Figure 1:** Typical installation of an ambient experience CT scanner, control room view

In the new ambient experience CT (Computer Tomography) scanner, developed at Philips Healthcare, the patients well being is improved by projection screens onto which images are projected during the scanning procedure, see Figure 1 and Figure 2. Unfortunately, the movies pictured on these screens suffered from blurriness. For reasons unknown at that time the projection screens wobbled, leading to blurry images. Since the images are projected onto the screens from above, see Figure 3, the screens have to be transparent and fairly thin. The screens are typically produced in Chlorinated Polyvinyl Chloride material, with a lateral dimension of 1410 x 1820 mm<sup>2</sup> and a thickness of 0.177 mm. Philips Applied Technologies in Eindhoven set out to identify the root cause of the wobbling of the screens, and to suggest possible remedies. The suspicion was that either flow-induced or noise-induced vibrations of the screens led to the image quality problems. Structure-borne transmission paths via the floor and the wall to the ceiling were also considered a possible cause. A series of experiments was set up from which the cause of the problem could be deduced. The measurements and the suggested solutions are described in this paper.

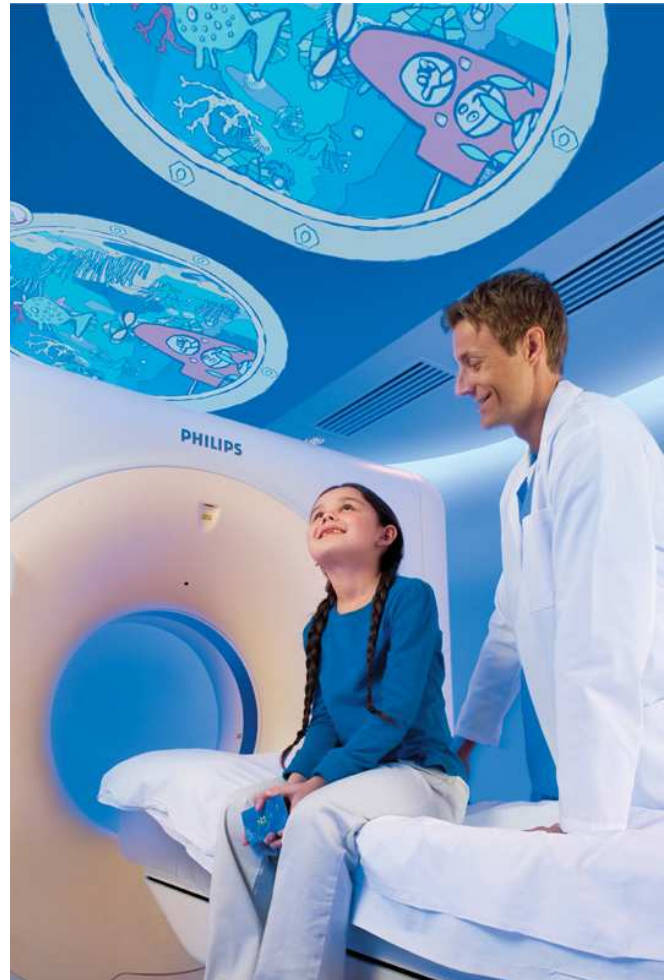
**Figure 2:** Typical installation of an ambient experience CT scanner, scanner view

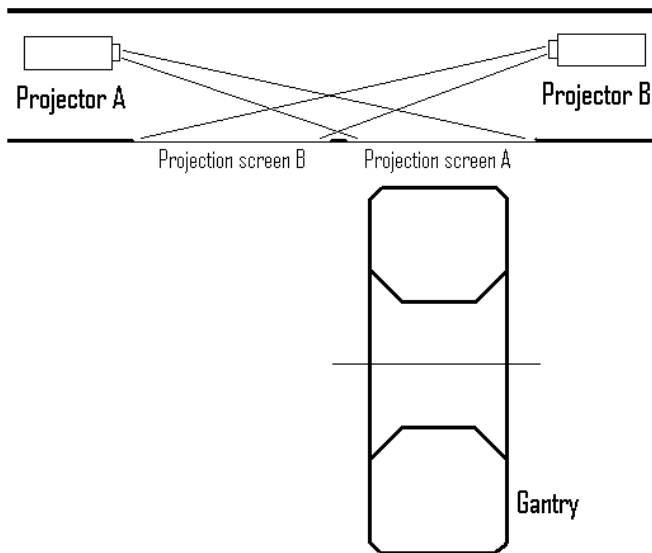
Figure 3: Ambient Experience CT projection method

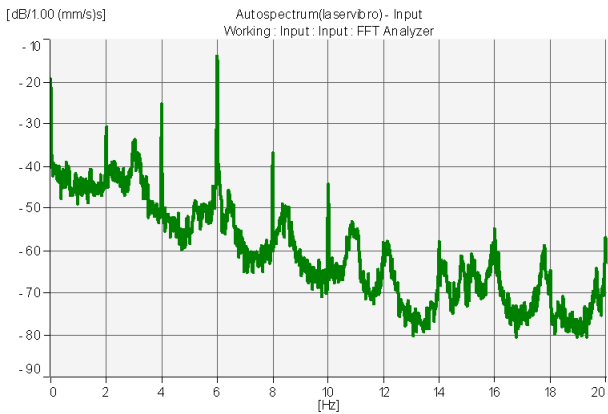
**Figure 5:** Displacement vibration levels projection screen, rotational speed gantry 2Hz (500 msec)

A series of experiments was carried out to find the root cause of the problem. First reference measurements were conducted. Vibrations of the projection screen were quantified by means of laser doppler vibrometry during operation of the CT scanner, the measurement set-up shown in Figure 4. The measured velocity autospectra at a rotational gantry speed of 2 Hz and 2.375 Hz are shown in Figure 5 and Figure 6, respectively. The distinct peaks in the spectra occur exactly at the fundamental frequency of the rotational speed and its harmonics. Thus a clear correlation exists between the wobbling of the projection screen and the rotational speed of the gantry.

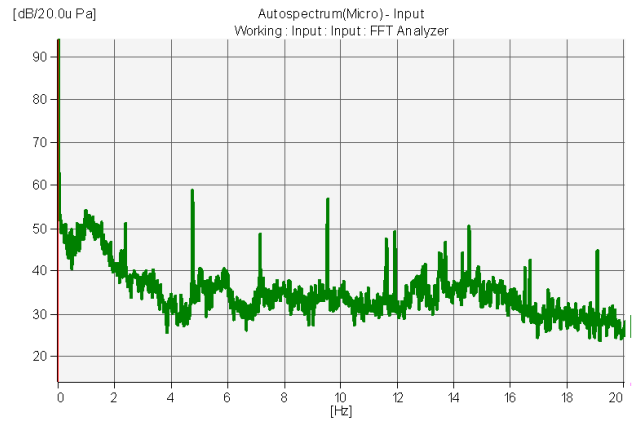
**Figure 7:** Sound pressure levels near projection screen, rotational speed gantry 2.375Hz (420 msec)

In addition to the laser vibrometry measurements of the projection screen, the acoustic pressure was measured as well, the measurement set-up shown in Figure 8. As expected, the sound pressure spectra also show distinct peaks at the gantry rotational speed and its harmonics, see Figure 7.

re  $20 \mu Pa$ . Compared to the experimentally obtained sound pressure level (see Figure 7) of 58 dB, this is in reasonable agreement. It confirms that the main transmission path is a structure borne transmission path. The vibrating gantry is radiating acoustic noise which brings the projection screen into vibration.

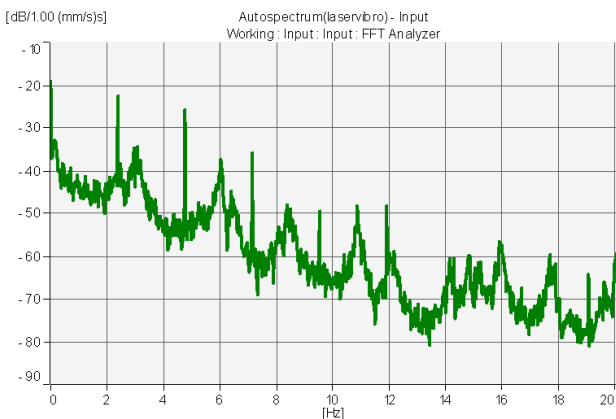
**Figure 6:** Displacement vibration levels projection screen, rotational speed gantry 2.375Hz (420 msec)

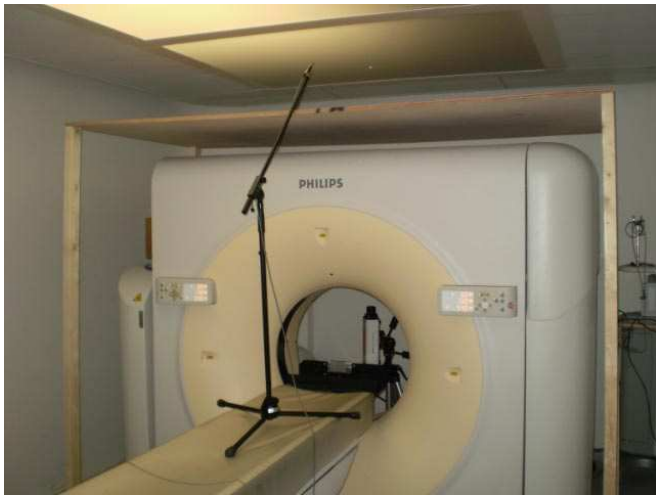
**Figure 9:** Plywood plate placed between the CT scanner and the projection screens

Next pragmatic shielding experiments were performed blocking the air flow coming out of the gantry, in an effort to assess the importance of this airborne transmission path. A number of shielding experiments were performed. Figure 9 shows a triplex plate standing on four wooden legs. This way of shielding appeared not to influence the vibrations of the projection screen significantly (only 1.7 dB reduction). Adding a 22mm foam layer to it, as shown in Figure 10 gave an additional (minor) 4.7 dB reduction. However, placing the triplex plate with foam on the top gantry, as shown in Figure 11, reduced the vibrations of the projection screen with an additional 10 dB, giving a total reduction of 16.5 dB as compared to the unshielded situation. Figure 12 summarizes the reductions achieved.

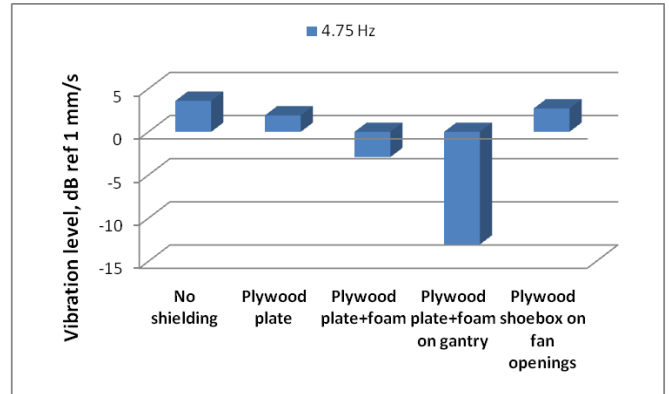
**Figure 12:** Vibration levels standard projection screen; effect of shielding on most dominant frequency component, rotation speed 2.375 Hz (420 msec).

at the top of the gantry by means of two wooden "shoebboxes", placed above the two openings. Quite surprisingly, closing the openings did not reduce the vibrations of the projection screen, as shown in Figure 12, last bar item. Whilst putting the triplex plate with foam on top of the gantry reduced the vibration level of the projection screen by more than 15 dB, closing the air outlets by means of the two wooden shoeboxes resulted in a marginally 2 dB reduction. This means that the excitation of the projection screen is not via an airborne path (via the fan openings). What remains is a structure borne transmission path.

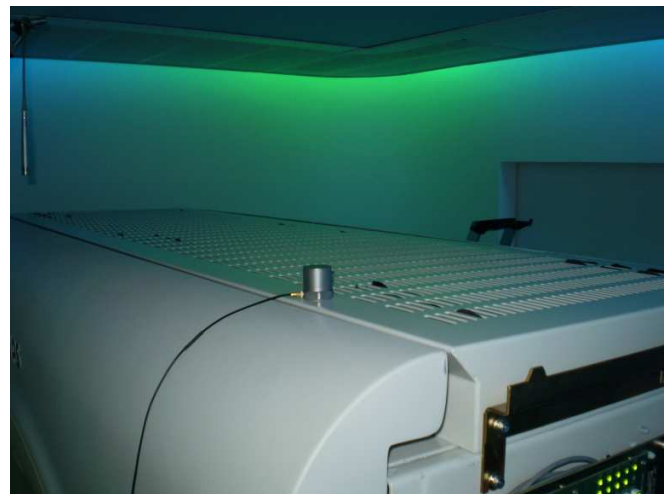
**Figure 13:** Accelerometer measurement set-up to determine the vibration levels of the CT gantry

To investigate the possibility of a structure borne transmission path, in which the gantry as a whole is vibrating and thus radiating acoustic noise, vibration measurements of the gantry were performed, see Figure 13 for the test set-up. The measured acceleration spectra are presented in Figure 14. The vibration level of the plate below the gridplate at 4.75 Hz, the most dominant frequency of vibration, equals  $-49 \text{ dB re } 1 \text{ ms}^{-2}$  ( $3.5 \cdot 10^{-3} \text{ ms}^{-2}$ ), corresponding to a velocity of  $1.2 \cdot 10^{-4} \text{ ms}^{-1}$ . The sound pressure thus radiated by the top part of the gantry can be roughly estimated by assuming a plane wave, which gives an acoustic pressure  $p = Z \cdot v = 400 \cdot 1.2 \cdot 10^{-4} = 0.048 \text{ Pa}$ , where  $Z$  is the acoustic impedance and  $v$  is the acoustic particle velocity. This rough estimates gives a sound pressure level of 67 dB

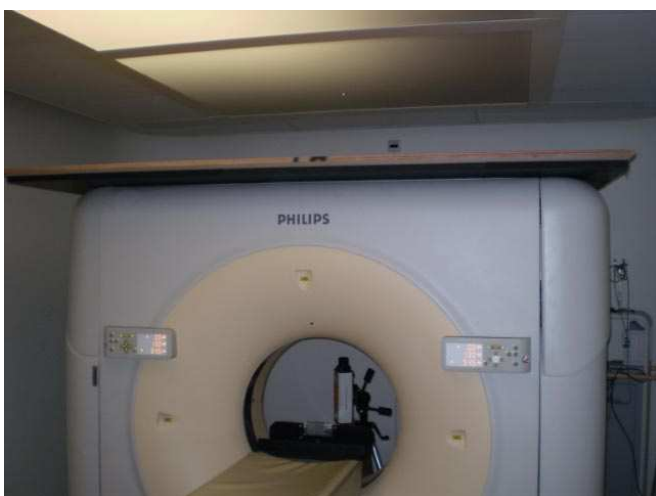
**Figure 11:** Plywood plate with absorbing foam lying on gantry
