Use of Higher-Harmonic Generation To Detecting Cracks due To Steel Corrosion In Reinforced Concrete

Jaime RAMIS¹; Marina MIRÓ²; Jesús CARBAJO²; Pedro POVEDA¹; Guillem de Vera²; Miguel Ángel CLIMENT²

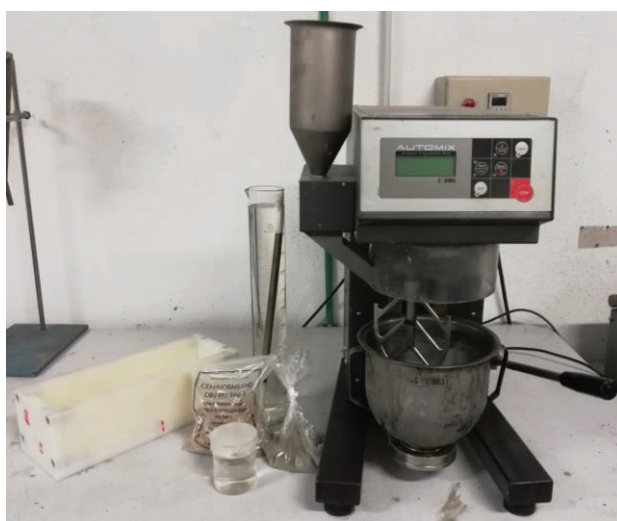
Figure 1 – Left: Preparation process. Right: Sample prepared.

First, the cement mortar was prepared mixing a standard siliceous sand aggregate and a sulphate resisting ordinary Portland cement, CEM I 52.5 R-SR 3, in accordance with the UNE-EN 197-1 standard [7]. A kneading process was then performed mixing the cement mortar with sodium chloride dissolved in water, being the Water/Cement (W/C) ratio used 0.5. The chloride sodium let obtain a 2% Cl^- relative to the cement weight in the hardened mortar and thereby accelerate the corrosion process. In a following step, the cement mortar mix was arranged in 100 x 100 x 350 mm³ plastic moulds for 24 hours before being extracted for mechanical compaction and curing during 7 days in a humidity chamber at 20 °C and 95 % relative humidity. Each of these moulds allowed centre-crossing a steel rebar of 12 mm in diameter along each sample 10 mm beneath its upper surface. The steel rebars were previously weighted and cleaned from native corrosion products following a recommendation procedure [8], covering the ends with vinyl electric tape to avoid the steel-mortar-air interaction. This layout was chosen so as to favour the micro-cracking produced by the corrosion process to emerge on the upper surface of the samples and thus ease the monitoring of the micro-crack width growth over time using a microscope. The preparation data of the cement mortar mix is given in Table 1.

Photographs of the sample preparation process and the final process are shown in Fig. 1 and 2.

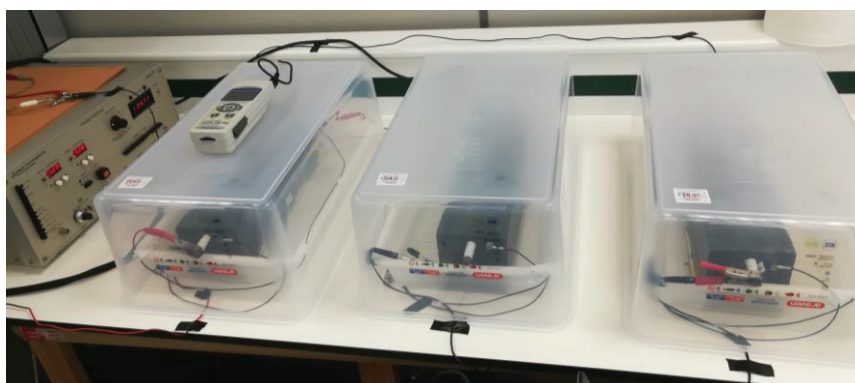
Figure 3 – Experimental setup of the forced corrosion test

The forced corrosion test was performed by using an electrophoretic power source that applied of a constant current density of $40 \mu\text{A}/\text{cm}^2$ between the steel rebar (anode) and an external galvanized steel grid (cathode) placed in the bottom of the specimens. Samples were partially submerged (5 mm height) in a recipient filled with tap water so as to keep an appropriate electric conductivity throughout the material, a polypropylene sponge being used between these and the steel grid. The forced corrosion test was then performed over each of the sets above described, the duration of the experiment being of 23 days for each set. Given that the electrophoretic power source provided a constant current density, it was possible to corrode three specimens simultaneously in a single test by connecting these in series. The tests were performed under pseudo-controlled conditions with a relative humidity of $84 \pm 4\%$ and a temperature of $23 \pm 1^\circ\text{C}$ to minimize the influence of additional factors on the measurements. Fig. 3 shows an image of the forced corrosion test.
