The renovation of De Doelen Concert Hall

M.Vercammen¹, M. Lautenbach²

¹ Peutz bv, Mook, The Netherlands, Email:m.vercammen@mook.peutz.nl

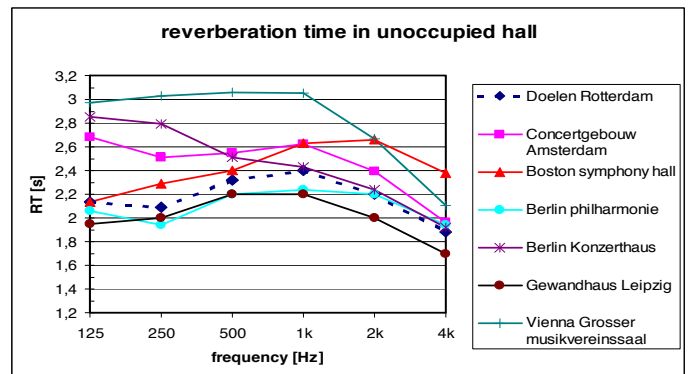
Figure 2: Reverberation times in De Doelen and other halls, unoccupied

Measurements (figure 2,3) show that it does not lack reverberance. On the other hand, for a hall this big a somewhat longer RT would still be possible. At lower frequencies the RT drops. This was originally not intended. The large volume and large number of seats causes a relative low strength, especially at large distance from the stage (see figure 4).

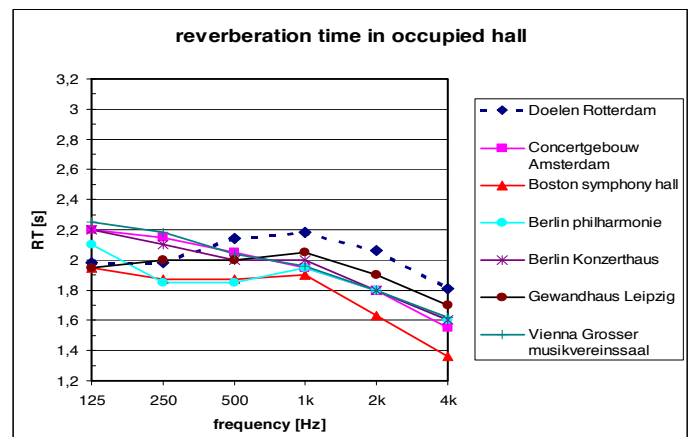
Figure 3: Reverberation times in De Doelen and other halls, occupied

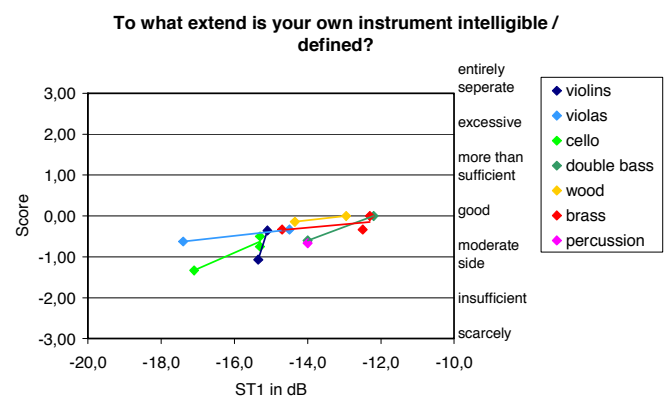
Figure 6: Relation between ST1 and musicians' own playing conditions

In addition to the questionnaires, measurements were made on stage, from several source positions to the middle of all instrument groups. These measurements were then correlated to the questionnaire results. Many of the energy parameters did not correlate to the subjective results. Only the ST1 (support) correlated to the result of the question on how loud the musician heard his own instrument back (see figure 6).

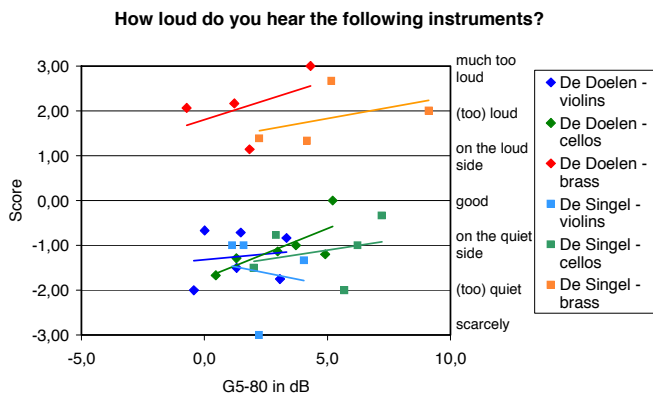
Figure 7: Comparison of G_{5-80} to the musician’s opinion regarding the loudness of other instruments

Although, for a certain value of Early Reflections Strength, the judgement differs for different instrument groups, within an instrument group there seems a consistent result. When asked “how loud do you hear a particular instrument group”, a higher value relates quite well to a higher G_{5-80} , see figure 7. Increasing the G_{5-80} on stage was one of the objectives for the renovation.

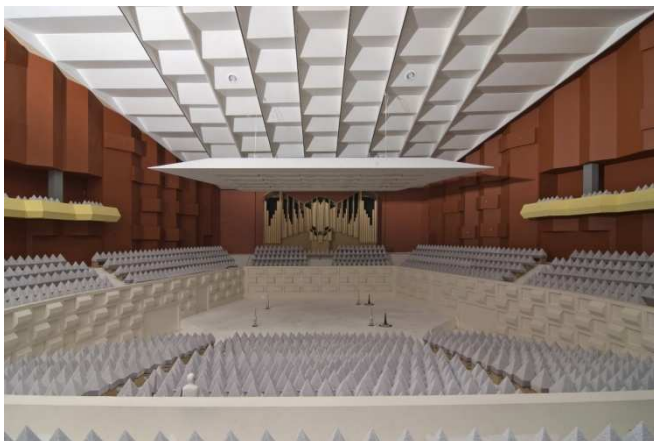
Figure 8: Picture of the 1:10 scale model of De Doelen with the new suspended technical ceiling above stage. In this ceiling the reflectors and lighting is integrated.

The scale model is made scale 1:10. The material is mainly mdf, painted to reduce high frequency absorption. The ceiling is made of 2 mm hard Polystyrene. The audience is made from foam material and placed on wooden strips. The measurements are done with special high frequency omnidirectional sources and 1/8“ microphones to be able to

A stage reflector is proposed to improve the support at the front of the stage and the ensemble conditions. The stage reflector is positioned at a height of 10.5 m above the front of the stage and has slightly curved panels for diffusive reflections back to the stage.

Figure 8 gives a picture of the scale model with the reflector. The flat edges will be made acoustically transparent. The theatre lighting will be integrated in this suspended technical ceiling. Several configurations of the reflecting panels were tested, mainly to limit the influence of the reflector in the audience area.

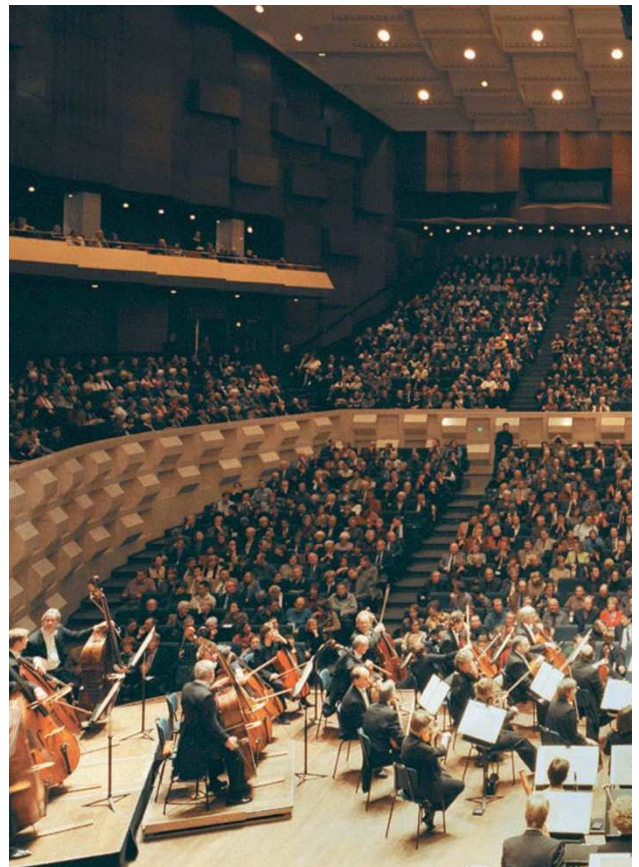
Figure 12: Picture of De Doelen

This ‚marble‘ (actually it is travertine) wall with its sound diffusing blocks is very characteristic for De Doelen (fig.12).
