Supplementary acoustic measures in the conference centre of the Federal Ministry of Economy and Labour

Michael Leistner, Helmut V. Fuchs

Fraunhofer-Institut für Bauphysik IBP, D-70569 Stuttgart, Germany, E-mail: michael.leistner@ibp.fhg.de

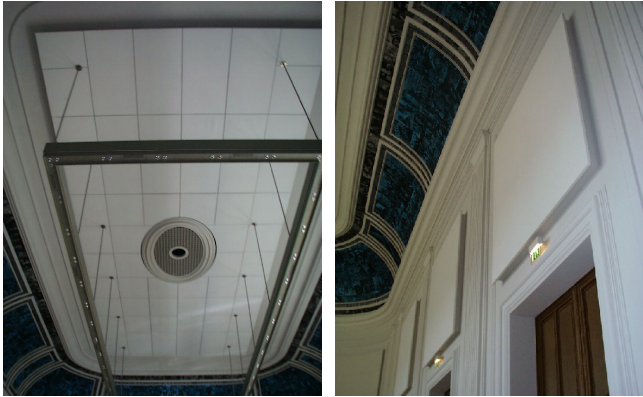
Figure 3: "Aula", Broadband Compact Absorbers at the ceiling behind a fabric lining.

Figure 4: "Aula", Compound Panel Absorbers behind a fabric lining above the doors.

The objective of the subsequent measures in the "Aula" consisted of lowering the reverberation time to values within the range of tolerance, predominantly in the mid and low frequency range. Two different approaches were taken: first, existing absorbers were replaced by more effective and more broadband ones, and second, additional surfaces for absorbers were found. A compromise was achieved among all parties involved, which permitted the installation of 10 cm to 25 cm thick highly effective innovative absorber modules [3], replacing the 3 cm acoustic plaster system. The ceiling was covered with 15 cm thick Broadband Compact Absorbers BCA according to [4] behind an acoustically

transparent fabric lining (Figure 3). 10 cm thick Compound Panel Absorbers CPA according to [4] were applied to the especially exposed places above the doors (Figure 4) and the media wall. Figure 5 shows measurement results of the absorption coefficient in a reverberation chamber of these novel absorbers, in comparison to the acoustic plaster system.

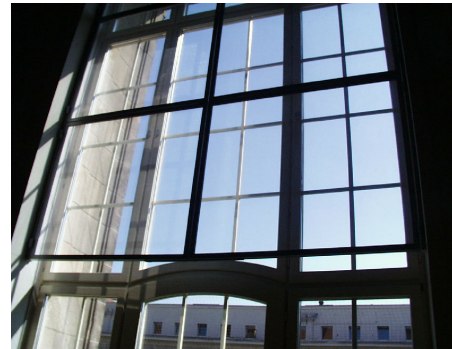
Figure 6: "Aula", absorbers made of micro-perforated acrylic glass in front of the windows.

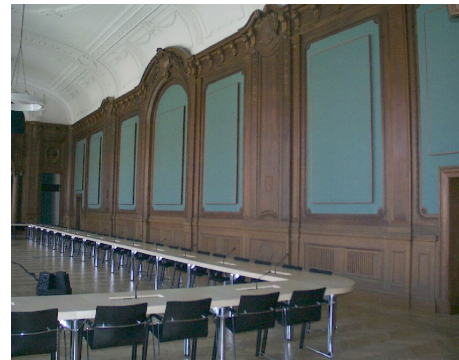
Figure 7: "Eichensaal", Broadband Compact Absorbers behind the fabric lining of the side wall.

In the "Eichensaal" the acoustically ineffective polystyrene boards behind the fabric linings of the side wall were replaced by highly effective 9 cm thick BCA (Figure 7).
